Letter to all schools and children's centres

Urgent Alert re: Accident caused by collapse of gate in Primary School

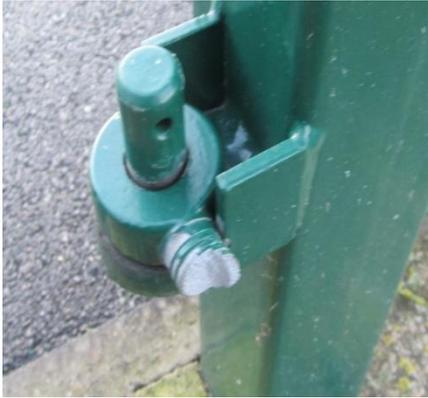
Photo 1: Gate post with 2 metal stops on lower hinge and part

1. Arrange for an urgent inspection of all your gates by a member of staff to determine if metal stops are fitted to the hinges of the gate AND have an eyebolt fitting. Please note these gates could be green weldmesh or some other design.

2. If your gates have **no metal stops fitted to the hinge** then ensure that gates are safely kept in a shut position or secured in an open position (e.g. with use of an attachment into the ground).

3. If you have one or more gates **with metal stops fitted** please inspect the eye bolt stem for any bending and **if any are found** please take the gate out of operation. You should arrange for the eyebolt to be replaced and metal stops removed before re use. The company who installed the gate, if known, may be able to assist with this. If your school is in in full MASS please contact the maintenance officer for your school. If the eyebolt appears in good condition then try and ensure that the gate is maintained in an open or closed position and is not allowed to be over extended thereby causing additional pressure on the eyebolt.

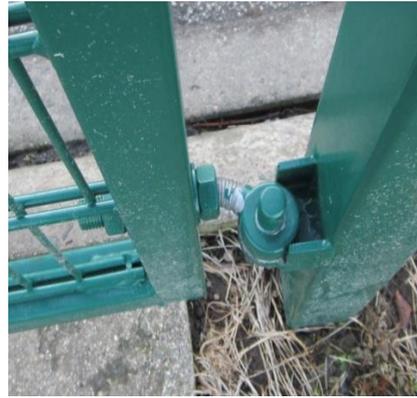
Photo 2: Bent stem of eye bolt (at same school)

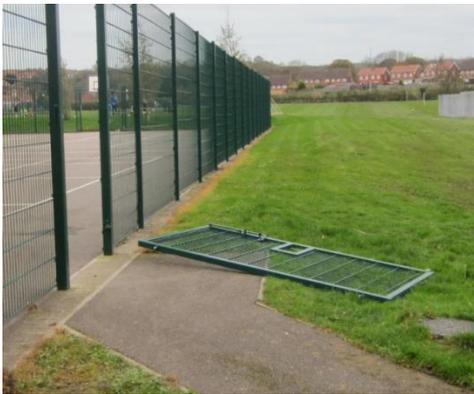
I wish to bring to your attention an accident which occurred on Friday 3 November 2017 at a primary school in North Yorkshire where a 6 year old pupil and a teaching assistant were both injured by a 1.8 metre green weldmesh gate which fell due to sudden failure of a lower hinge. The pupil suffered a head bump and the teaching assistant a suspected chipped bone in her left arm. Clearly these injuries could have been more serious. Our investigation is still ongoing but to date we believe the main cause of the sudden sheering of the eyebolt on the lower hinge was due to the presence of 2 metal stops or lugs welded on to the hinge (designed to prevent finger trapping if the gate over closes). With daily use, the metal stops put additional pressure on the eyebolt causing the stem of the bolt to bend and eventually fracture (see photos below). There was evidence of bending of eyebolt stems on three other gates at the same school. These gates also had similar metal stops in situ adjacent to the eye bolt AND were accessed readily by pupils.

Photo 3: Gate involved in accident
